## FLUTTER TESTS OF B-34 FIN-RUDDER-TAB SYSTEM

By Theodore Theodorsen and N. H. Smith

MEMORANDUM REPORT

Army Air Forces, Materiel Command

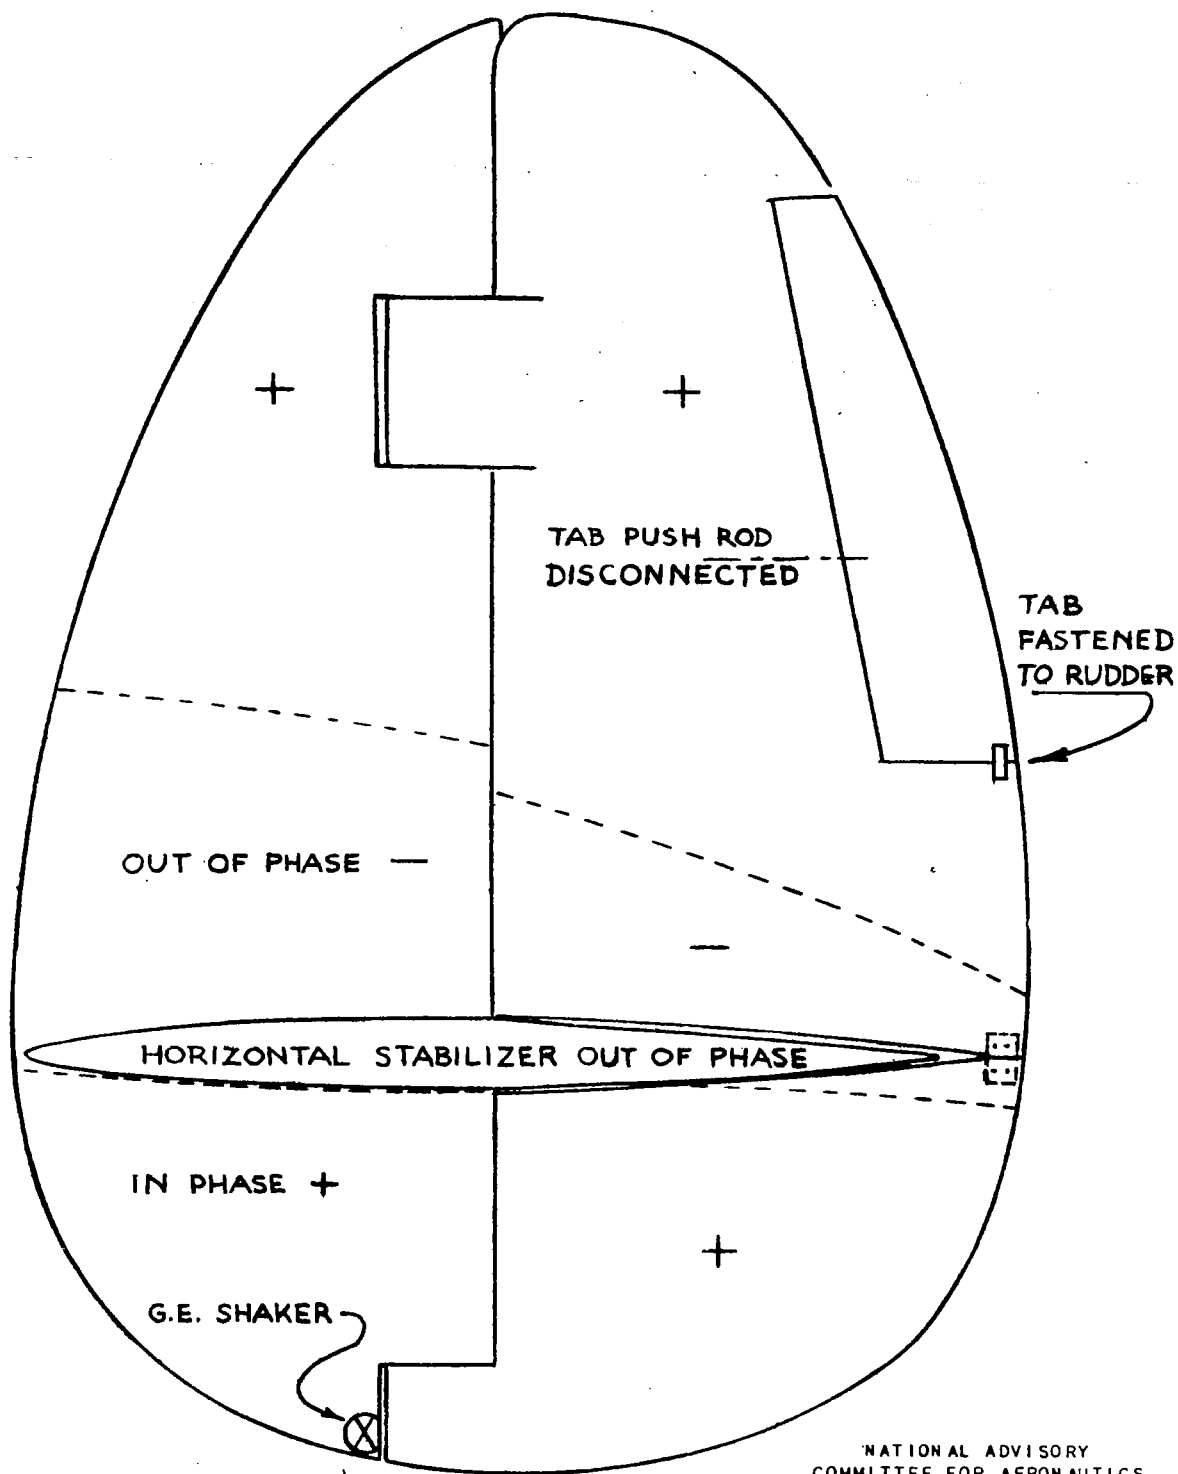
Table II and the oscillograph record in figure 7 show the rudder paddles and the upper-rudder trailing edge to be essentially in phase with one another in the case of the mild flutter. These parts of the rudder are in phase in the vibration mode pictured in figure 1. Also, the tab frequency is very near the frequency for this mode. It is therefore concluded that the flutter mode consisted of a coupling between the tab and the mode of figure 1.

Figure 1.- Mode of vibration at 31.5 cps.

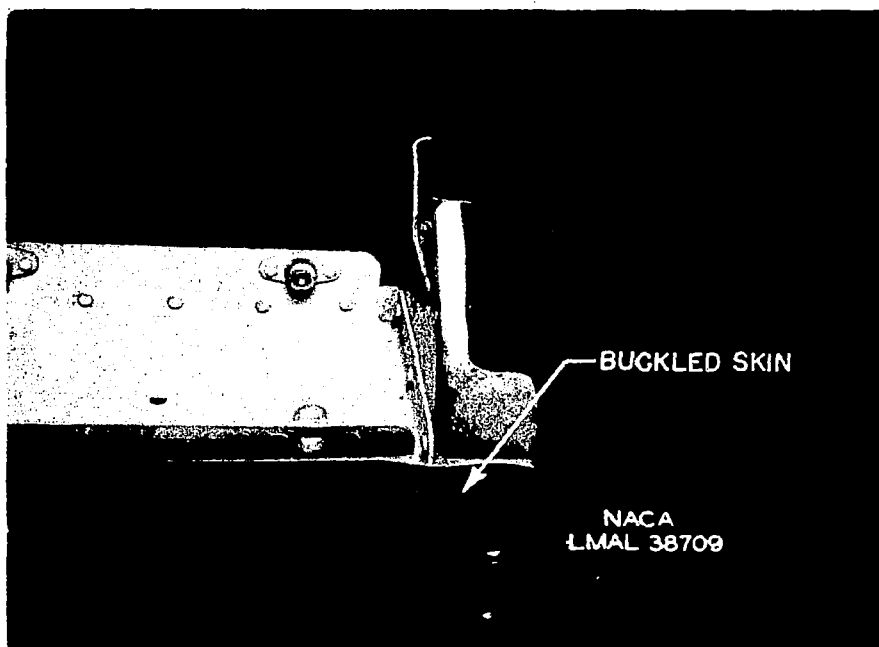
first encountered during a period of rather rapid increase in the speed of the tunnel, and the tab motion became excessive. The flutter caused damage to the rudder trailing edge at the tab push-rod cut-out and the skin of the upper rudder was buckled slightly in the vicinity of the rudder mast. This damage is shown in figure 5.

(b) Buckled skin on upper part of rudder.

Figure 5.- Damage to rudder caused by flutter which occurred during rapid increase in speed of tunnel.

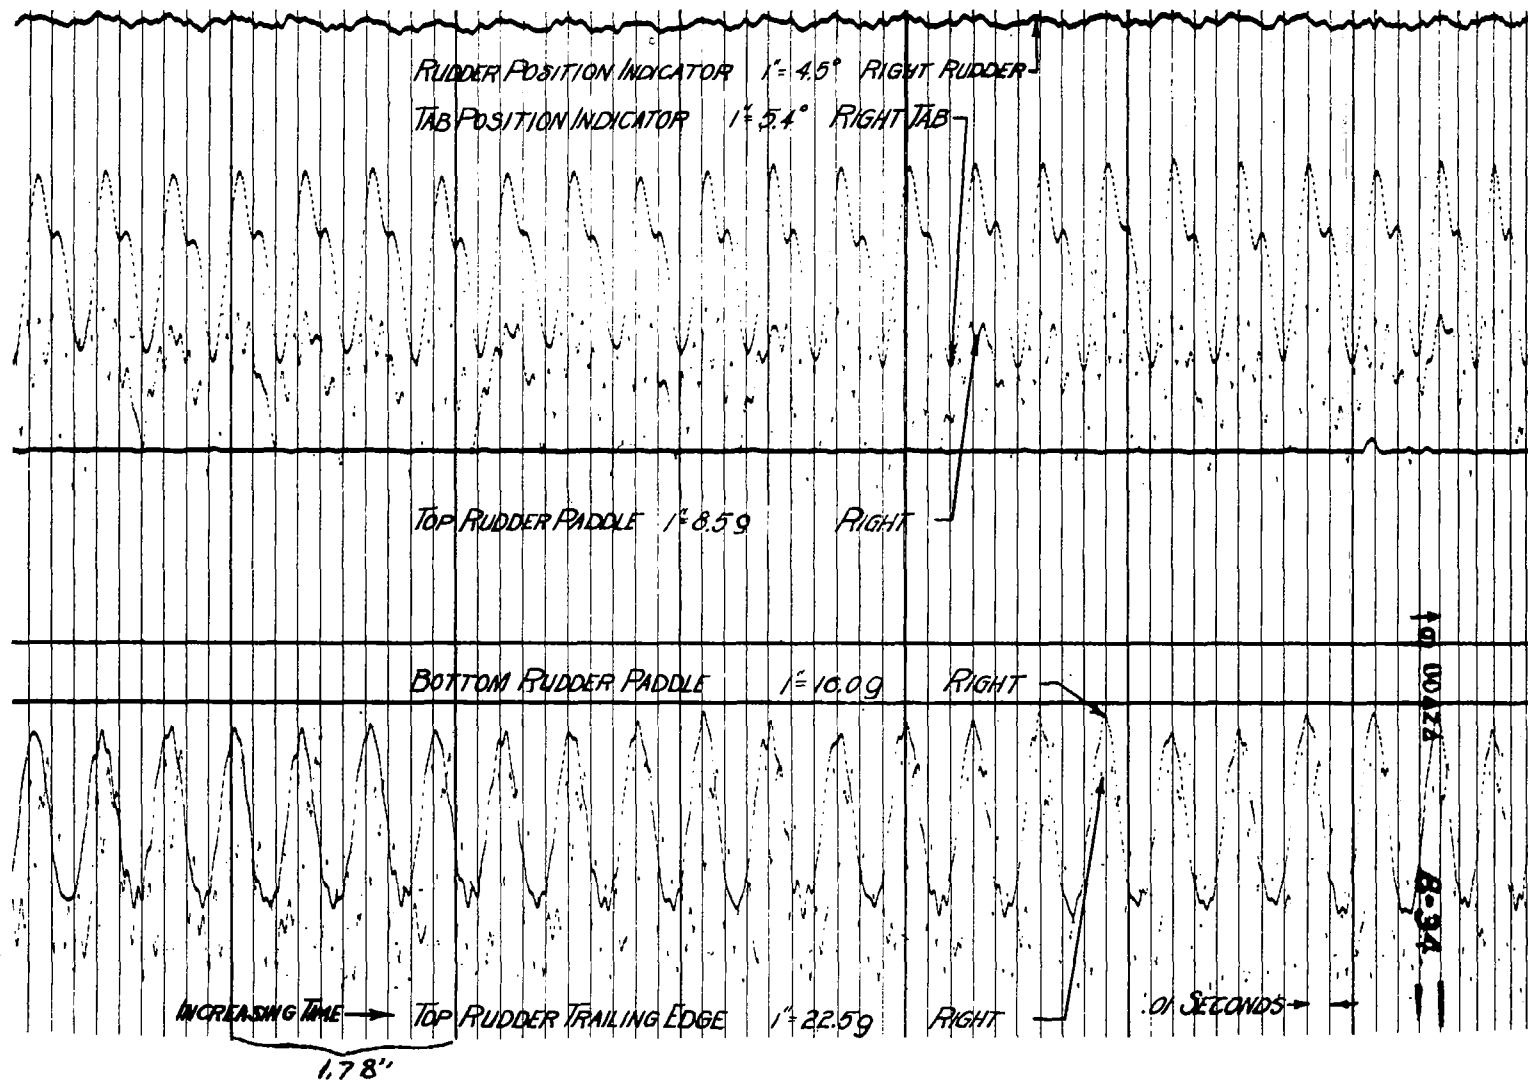
Figure 7.- Typical oscillograph record showing mild flutter. Tab play,  $0.60$ ; velocity,  $308$  mph; Mach number,  $0.392$ ; tab frequency,  $32.5$  cps.
